**DRAFT GEOTECHNICAL INVESTIGATION REPORT FOR
21.22-ACRE POLOPOLUS SITE PROPOSED COMMERCIAL
DEVELOPMENT**

7270 Hamner Avenue
City of Eastvale, Riverside County, California
Converse Project No. 14-81-55-02

May 12, 2017

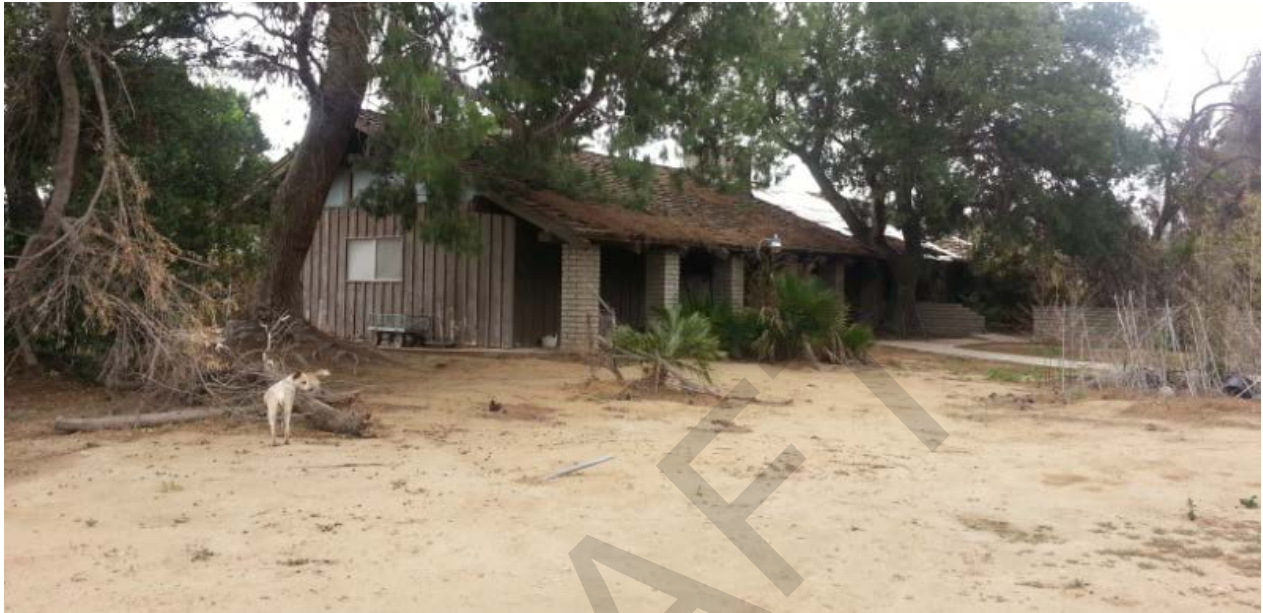
Photograph No.1, Private residence

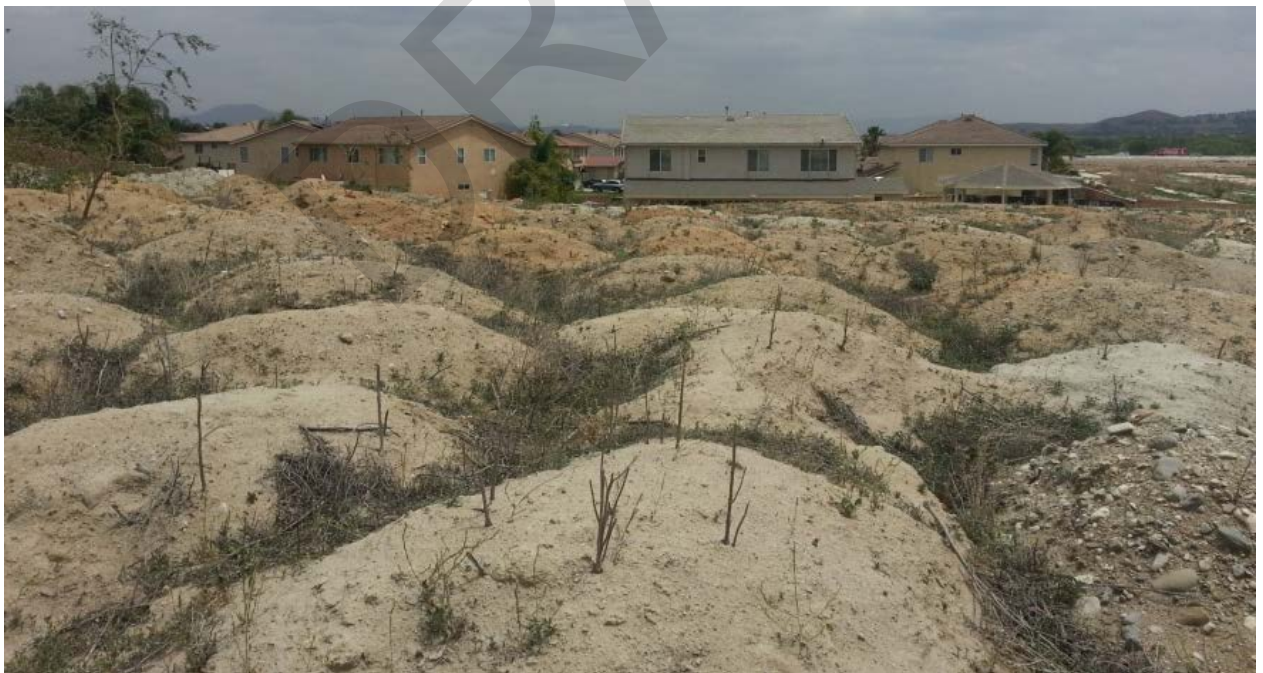
An approximately 200-foot by 400-foot area in the southeastern corner of the site was covered by loose piles of end-dumped soil as shown in Photograph No. 2, but we understand the piles were spread soon after our investigation field work. The soil piles contained rebar, concrete, and wood debris. Debris piles, containing dead trees and potting containers, were observed on other parts of the site.

Photograph No. 2, Piles of dumped soil

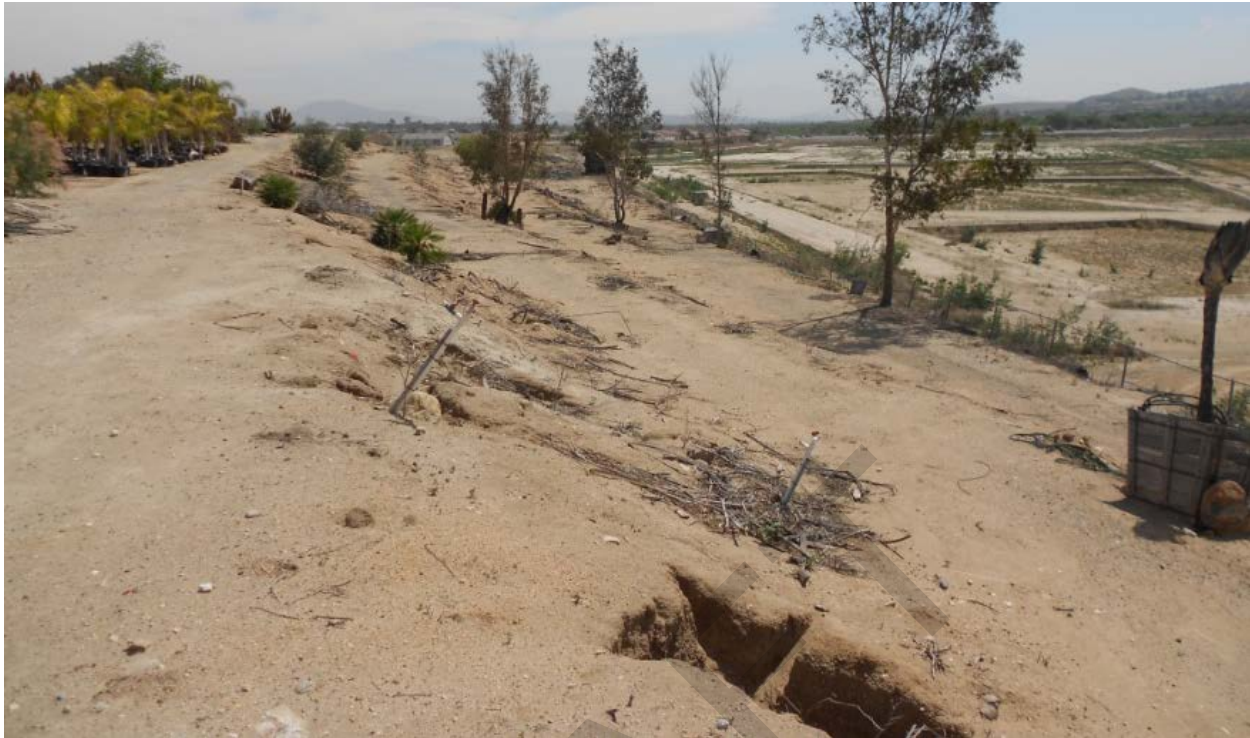
- A portion of the southern half of the site has been previously graded into 3 northeast-southwest oriented terraces. The terraces are separated by approximately 2:1 (horizontal:vertical) slopes of approximately 4 to 8 feet in height. The slopes appear to be in poor condition, with areas of erosion and vegetation.

Photograph No. 3, Terraces along the southeast property line

The southeastern site boundary has been graded into three northeast-southwest-oriented terraces as shown in Photograph No. 3. The terraces are separated by approximately 2:1 (horizontal:vertical) slopes of approximately 4 to 8 feet in height. The slopes appear to be in poor condition, with areas of erosion and vegetation including trees and low level grasses. Vegetation within the rest of the site consists of scattered stands of trees, areas of low to mid-level bushes and low level grasses.
