**COMPREHENSIVE ASBESTOS CONTAINING MATERIALS SURVEY  
AND  
LIMITED LEAD-BASED PAINT INVESTIGATION**

**Al's Corner Project**

**7010 Hamner Ave  
Corona, California**

December 3, 2007

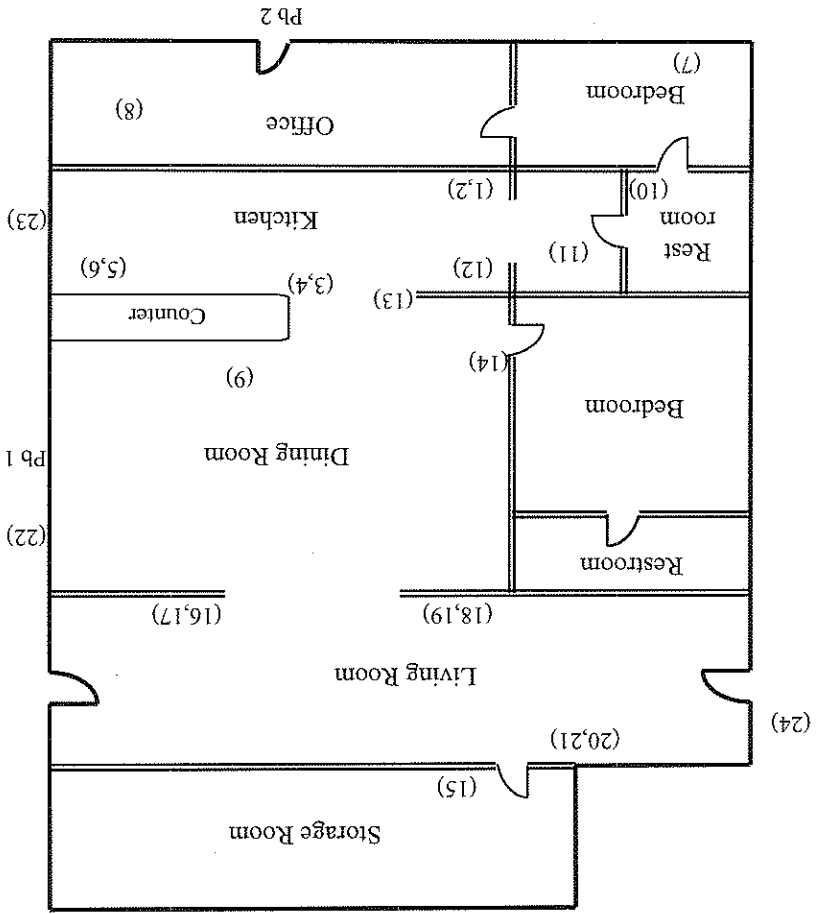
**Figure 2**

**Roof Samples**  
 Flat Roof: 25-27  
 Pitch Roof: 28-36

**House**

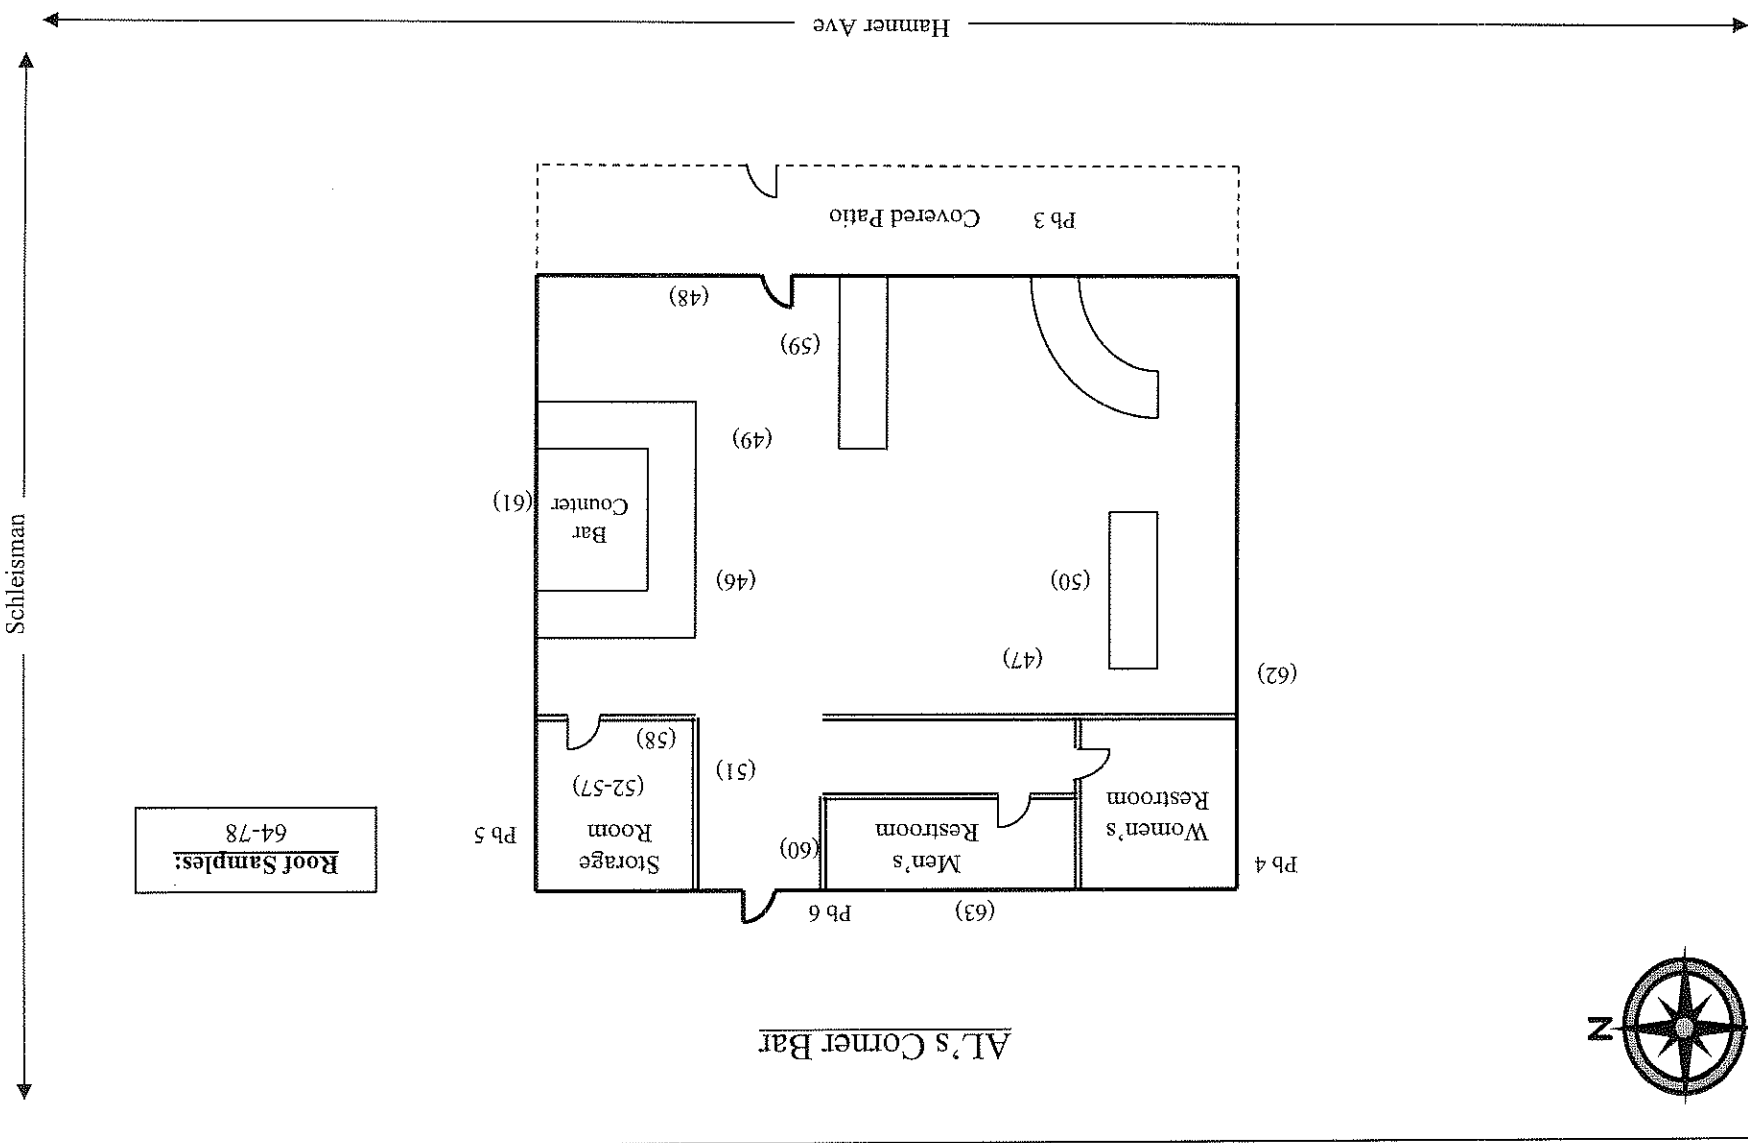
Al's Corner Bar

Roof Samples:  
64-78
